2020 Culverts/Closed Drainage Systems (CCDS) Report Gilmanton, New Hampshire

Loon Pond Road Metal Culvert in Gilmanton, NH.

Lakes Region Planning
Commission 103 Main
Street, Suite 3
Meredith, NH
03253
Lakesrpc.org

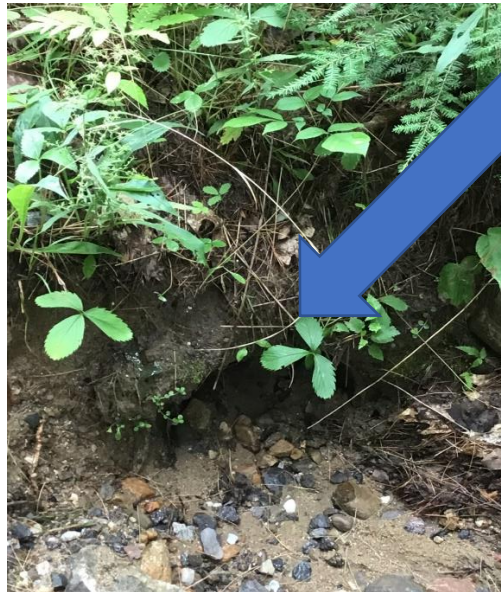
C.

The culvert and headwall are tough to see because of the overgrown vegetation and erosion. The arrow is pointing to the actual location of the culvert.

Figure 3: Inlet and Outlet End Treatment Images
A: Masonry, Headwall on Joe Jonas Road B: Concrete, Headwall on Sawyer Lake Rd C: N/A, Headwall on Beaver Dam Drive
